## CERTIFICATE OF APPROPRIATENESS

**Property:** 8815 Dover Street, Lot 4, Block 55, Glenbrook Valley Section 9 Subdivision. The property includes a historic 2,404 square foot, one-story wood frame single-family residence and attached garage situated on a 7,150 square foot (65' x 110') interior lot.

**Proposal:** Alteration – Windows.

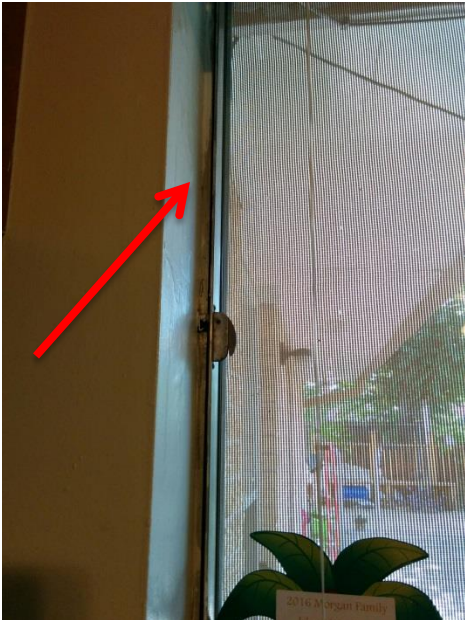
*Window C Interior: Differential settlement has caused separation of the window from the structure. This window is no longer operable.*

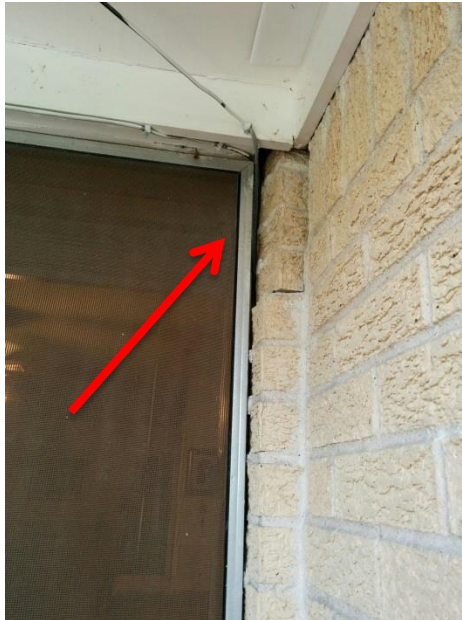
*Window C Exterior: Differential settlement has caused separation of the window from the structure. This is evidenced by the gap as well as the displaced brick.*

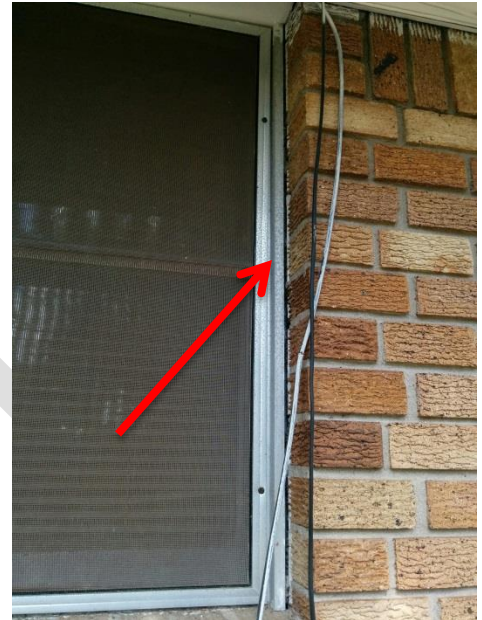
*Window F Exterior: Differential Settlement has caused the separation of the window frame from the building.*

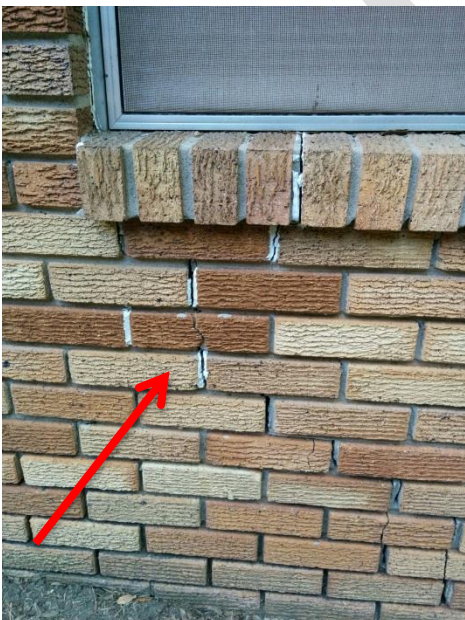
*Window I Exterior: Evidence of foundation failure that has led to the window wracking out of square and being rendered inoperable.*

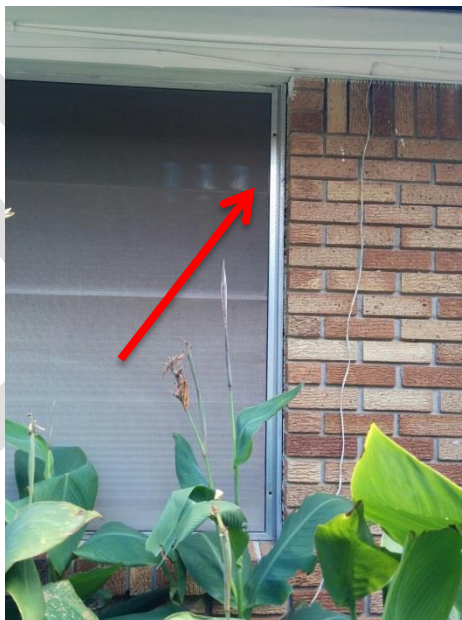
*Window H Exterior: Differential settlement has caused the window to separate from the structure.*

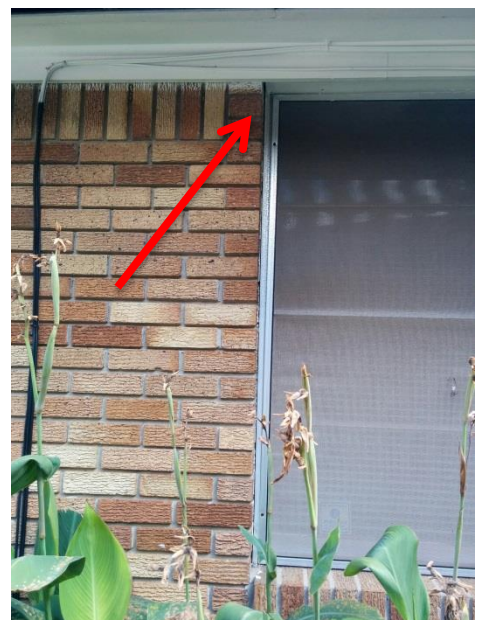
*Window H Exterior: Differential settlement has caused the window to separate from the structure.*
